### 3 EQUIPMENT PERFORMANCE IN PAST AND RECENT EARTHQUAKES

#### 3.1 *Tohoku 2011*

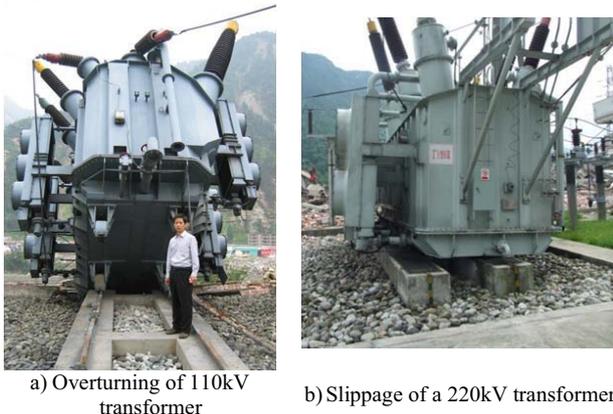
transformers slid, dropped, even overturned during the earthquake. This failure mode lead to complete failure of the equipment due to internal damage or damage to components including cores/coils, bushings, radiators, conservators and other accessories. In many cases, damage to transformer internals caused faults sometime after the earthquake leading to fires and complete loss of the transformer. The large displacements of the transformers from tipping or sliding lead to ruptures of rigid and flexible connectors attaching other equipment to the transformer components.

The observed damage modes of transformers were mainly as follows: (a) slippage of an anchored transformer on its foundation, (b) falling off the foundation on the ground if displacement exceeded the foundation dimensions, (c) collapse due falling on the ground, (d) oil leakage of transformer bushing, and (e) damage of accessories caused by the large displacements of transformers. The most common modes of failure were modes (a) through (c) and in many cases they resulted in modes (d) and (e). Because the mass of a transformer is extremely high, a vibration of a transformer during strong earthquake produces a large inertia force that can cause slippage, overturning, or collapse. Figure 1 shows some typical transformer failure modes observed in this earthquake.

Figure 1. Typical failure modes of transformers in China.

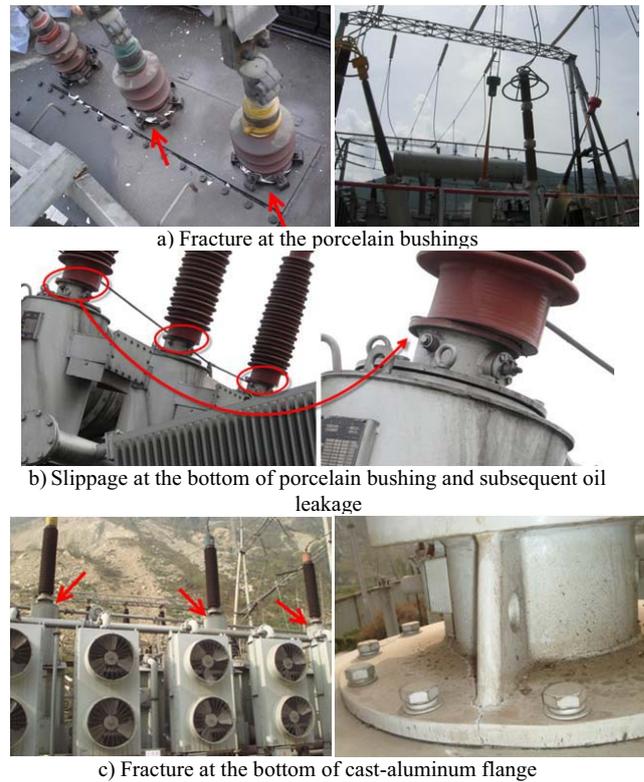
**Damage to transformer bushings.** Bushings are typically attached by bolting to the top plate of a transformer tank, or to a turret extending from the top of the transformer tank. The bushings are installed in plumbed and inclined configuration. In the latter case, the angle between the longitudinal axis of the bushing and the vertical direction can vary and was about 20 degrees for the bushings investigated after the earthquake. Structurally, bushings represent long and slender members with the majority of them made from porcelain. In many cases the flexibility of the top plate of the transformer caused a significant amplification of the ground motion leading to large bending moment and shear force at the base of the bushing. The results of this amplification combined with poor structural strength and brittleness of the porcelain demonstrated extremely high vulnerability of the bushings to the effects of this strong earthquake. Porcelain bushings may exhibit different failure modes depending on the style of construction. Center-clamped porcelain bushings derive their lateral load-resisting capacity from a post-tensioning force

applied through the core of the bushing. Such bushings typically fail by slippage of the bottom porcelain/gasket on the bushing flange resulting in oil leaks or gasket ejection. Bushings may also be constructed with porcelain sections that are grouted or mechanically clamped to the bushing flanges. These bushings may also fail by slippage accompanied by oil leak, or by porcelain fracture. Figure 2 shows the typical failure modes of bushings in Wenchuan Earthquake, which includes (1) fracture at the base of the bushing as shown in Figure 2a, (2) movement of the upper porcelain unit relative to its support flange and extrusion of rubber gasket as presented in Figure 2b, and (3) fractures at the cast-aluminum flange of bushings as shown in Figure 2c.

Figure 2. Typical failure modes of transformer bushings in China.
